Five-Year Review Report

Second Five-Year Review Report Hi-Mill Manufacturing Co. Superfund Site Highland Township, Oakland County, Michigan

U.S. Environmental Protection Agency
Region 5
Chicago, Illinois

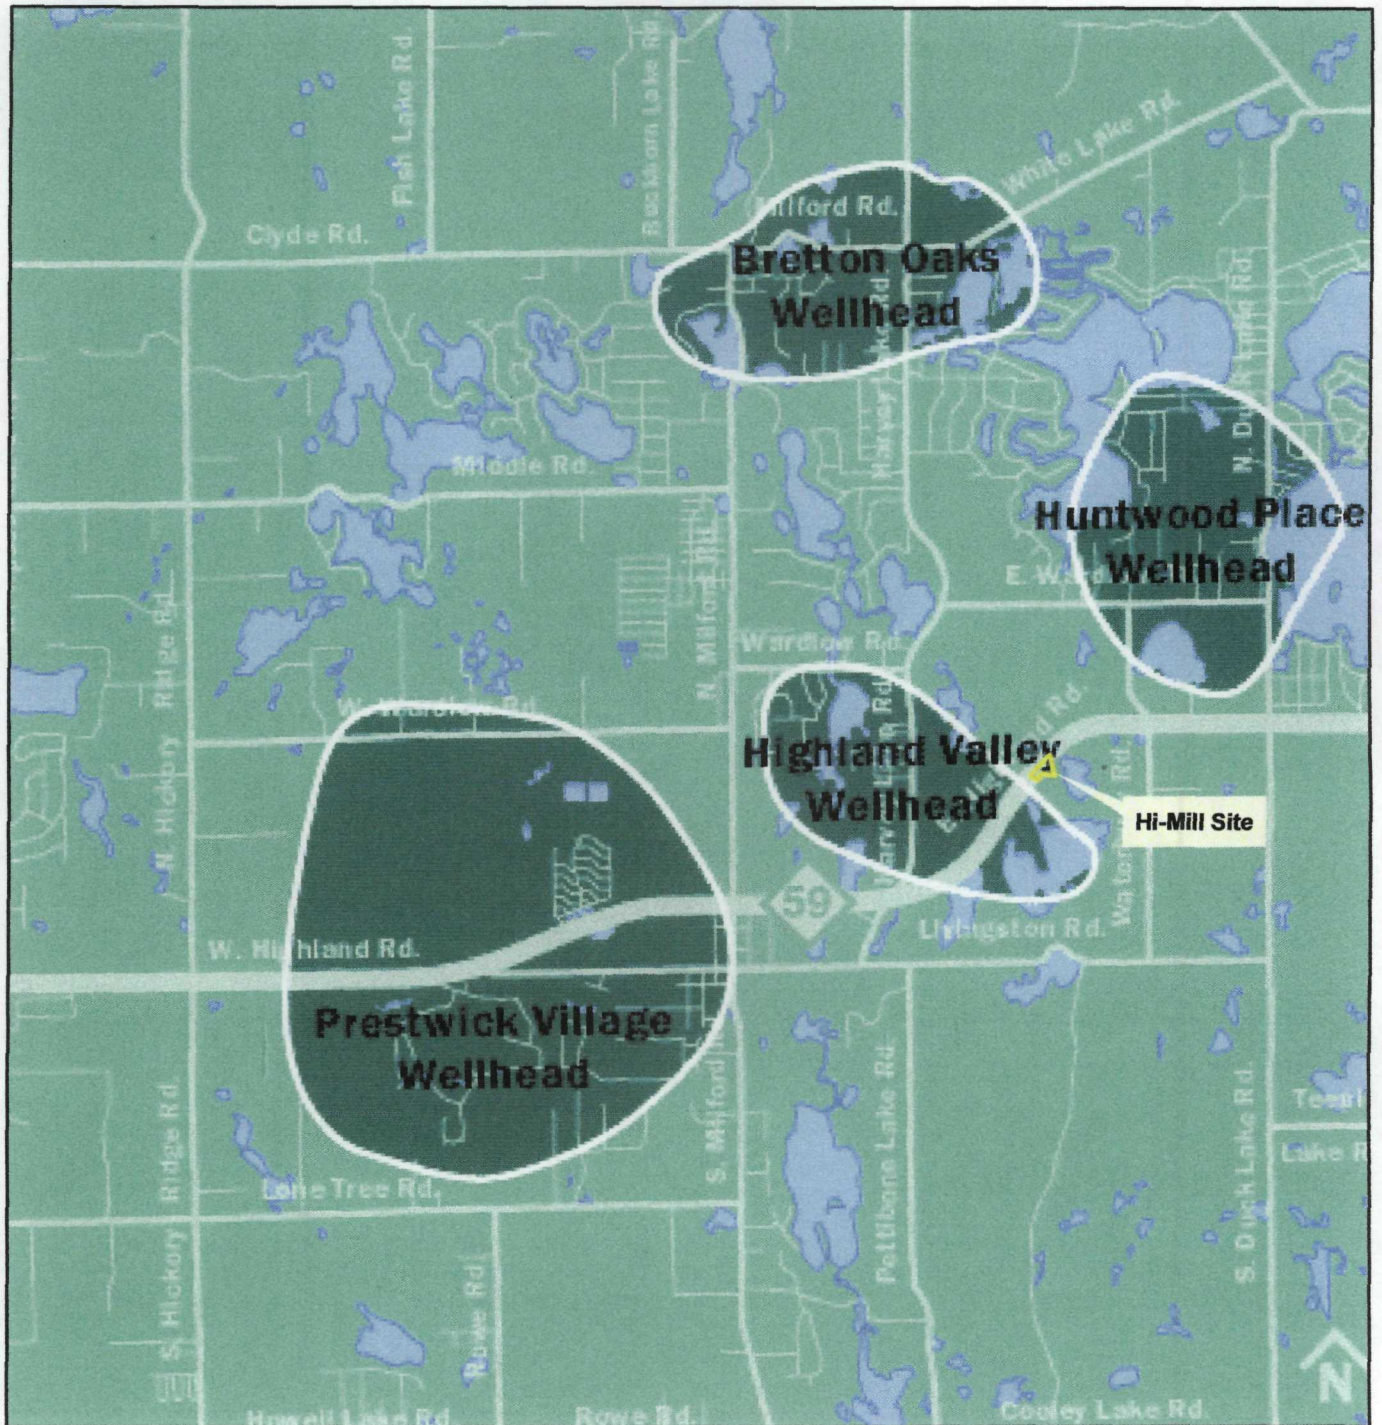
Figure 5

at least one on-site monitoring well and may also be present in an off-site monitoring well. As noted above, since the time the ROD was written, several community wells were installed near the site. The Wellhead Protection Area estimated for two of the new community wells appears to overlap with part of the Hi-Mill groundwater contamination plume.

Hi-Mill Manufacturing Site Wellhead Protection Areas in Highland Township

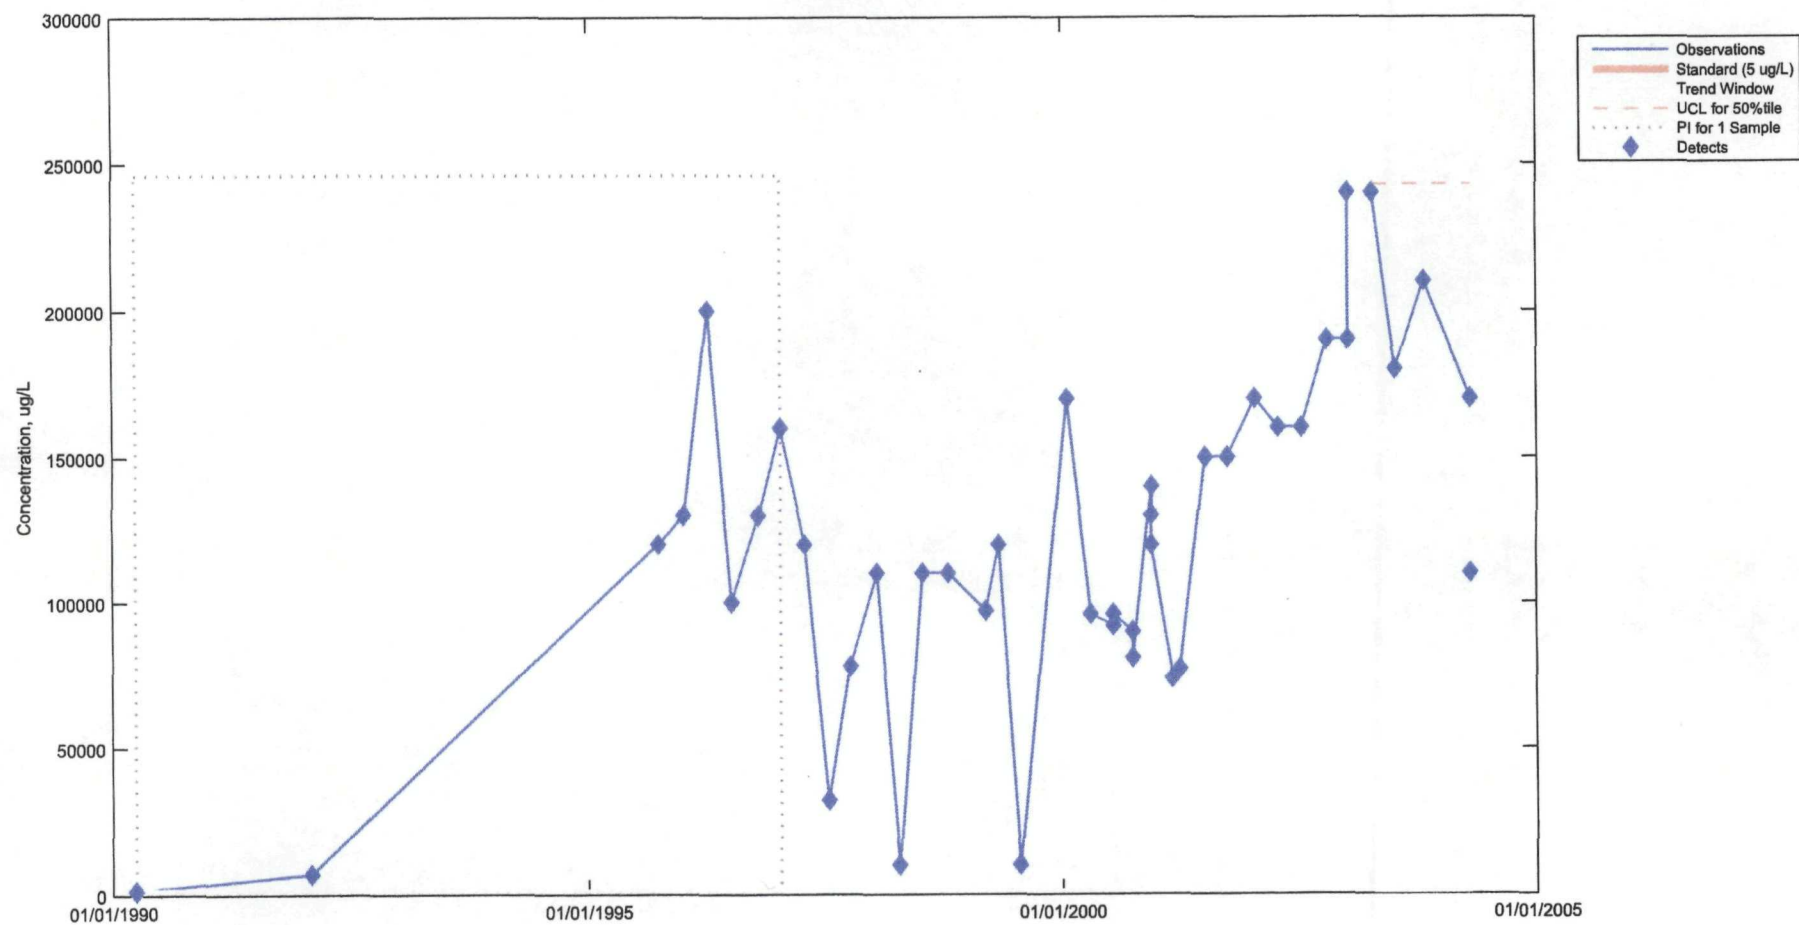
**SW-1
TRICHLOROETHYLENE (TCE)
Hi Mill**

Standard Test (95%): Exceedance <UCL = 2.43e+005 ug/L>
Baseline Test (95%): No Change <UPL/LPL = 2.46e+005/0.00e+000 ug/L>
Trend Test (95%): Upward <Slope = 1.19e+004 ug/L/year>

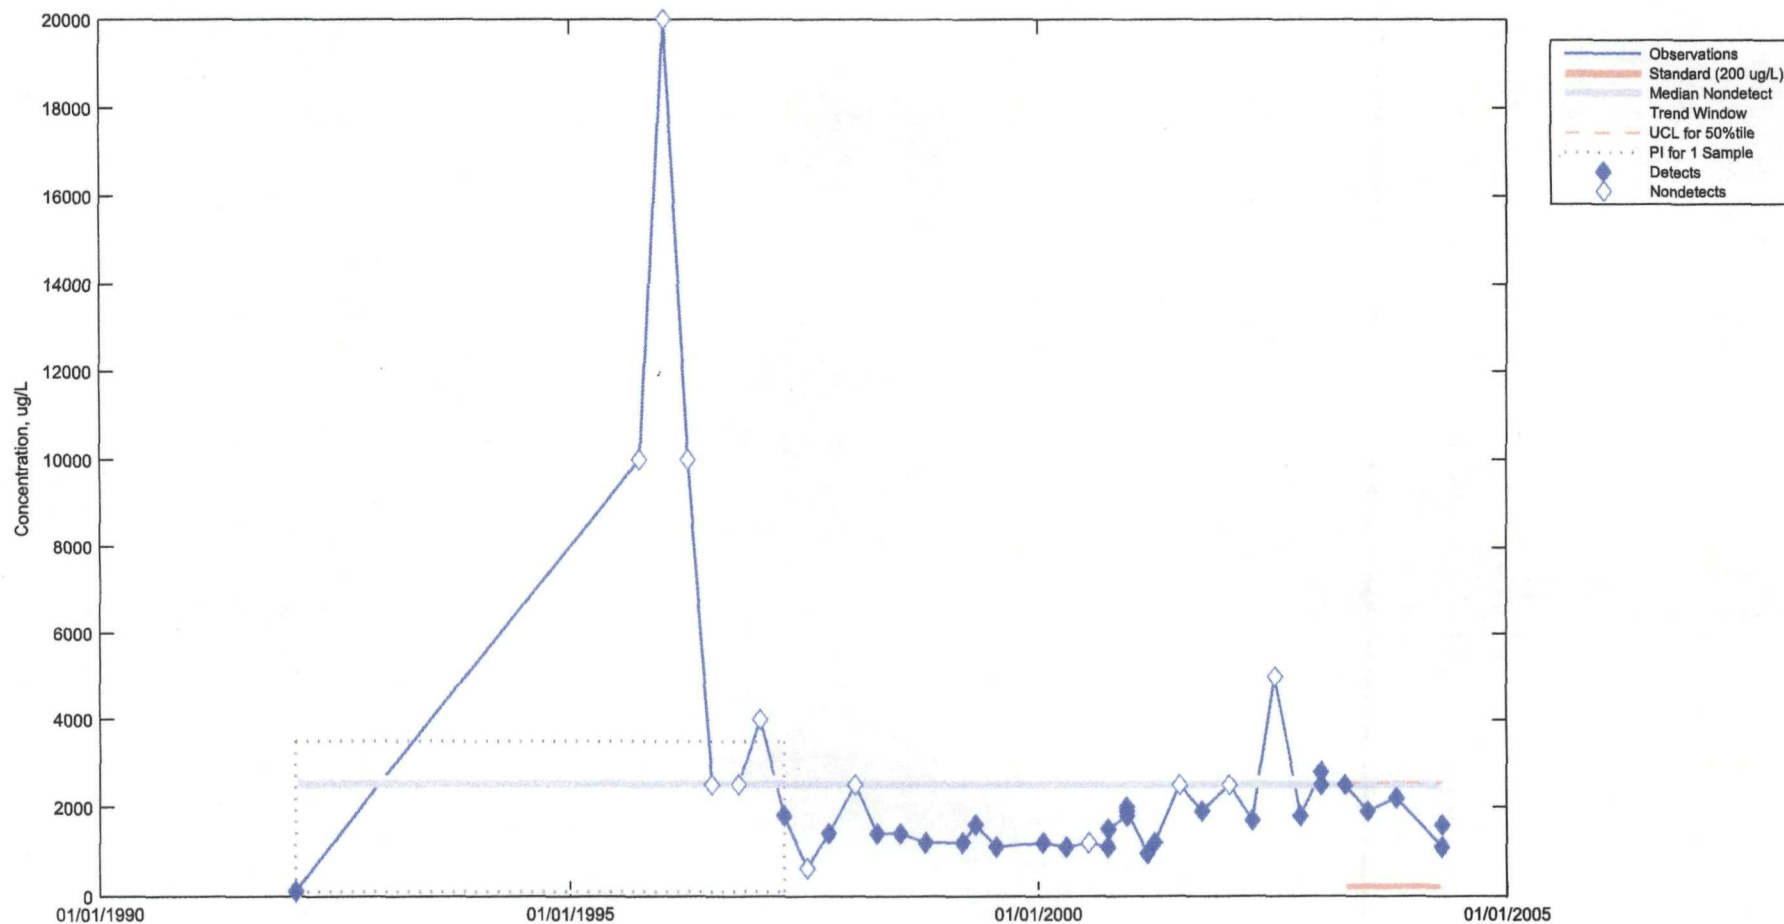
**SW-1
1,1,1-TRICHLOROETHANE
Hi Mill**

Standard Test (95%): Exceedance <UCL = 2.56e+003 ug/L>
 Baseline Test (95%): No Change <UPL/LPL = 3.50e+003/1.00e+002 ug/L>
 Trend Test (95%): No Trend <Slope = 5.93e+001 ug/L/year>

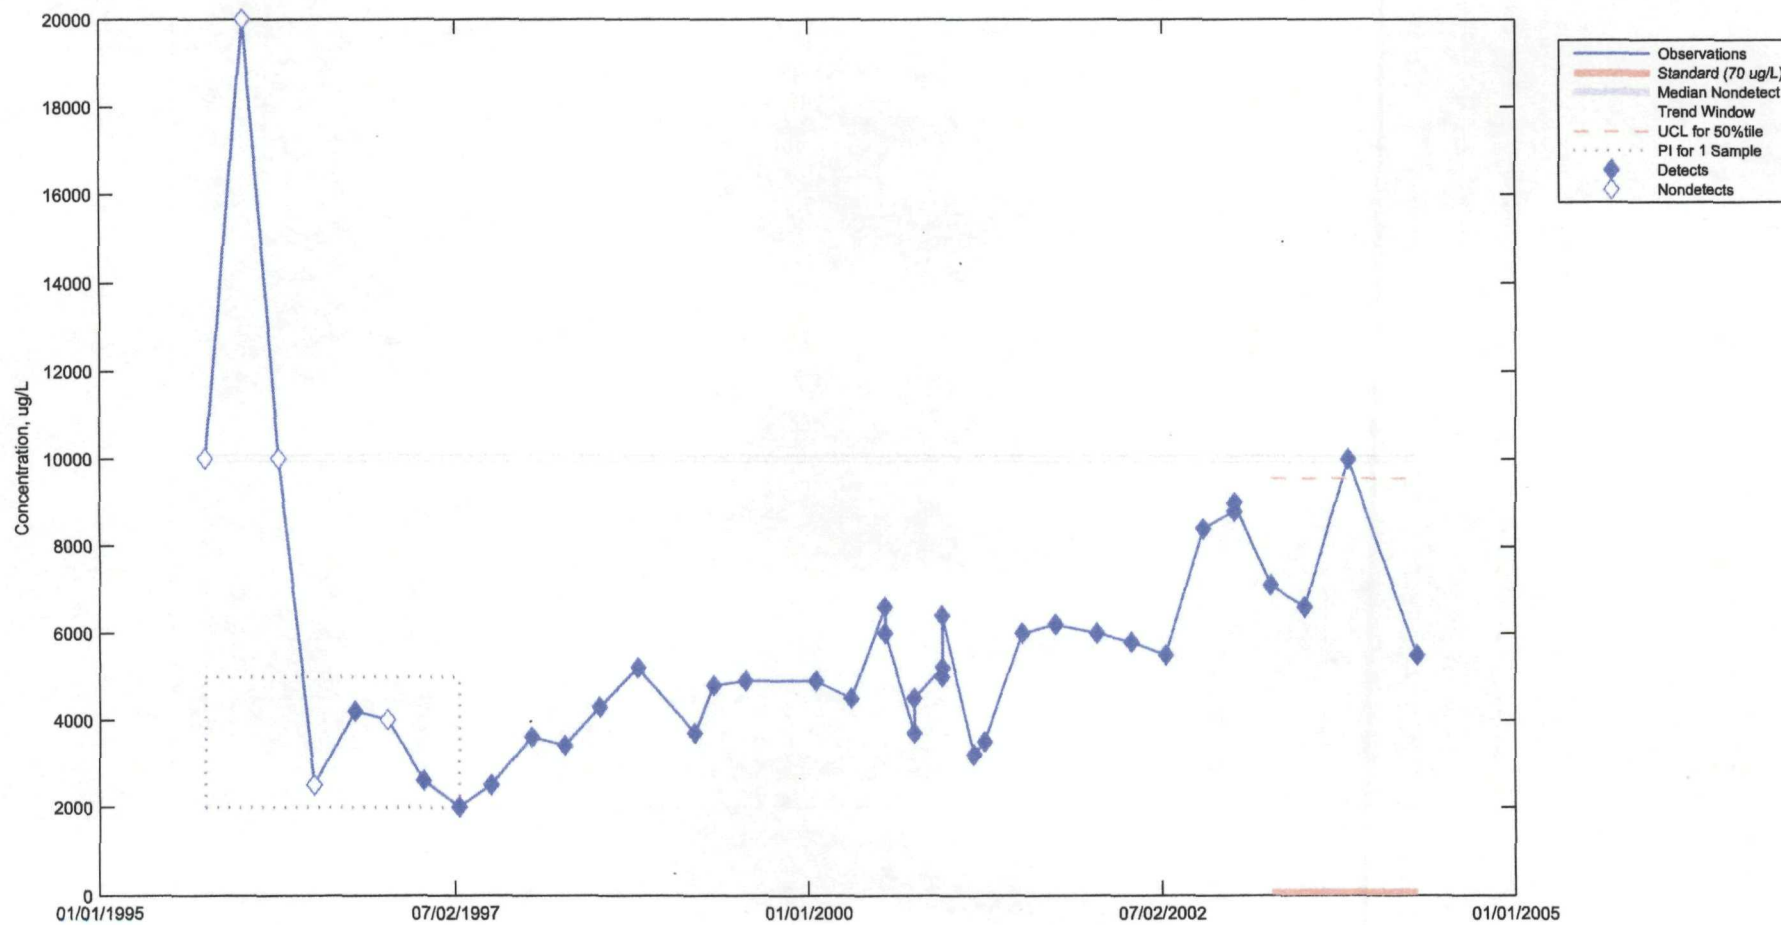
**SW-1
CIS-1,2-DICHLOROETHYLENE
Hi Mill**

Standard Test (95%): Exceedance <UCL = 9.56e+003 ug/L>
Baseline Test (95%): Worse <UPL/LPL = 5.00e+003/2.00e+003 ug/L>
Trend Test (95%): Upward <Slope = 3.93e+002 ug/L/year>

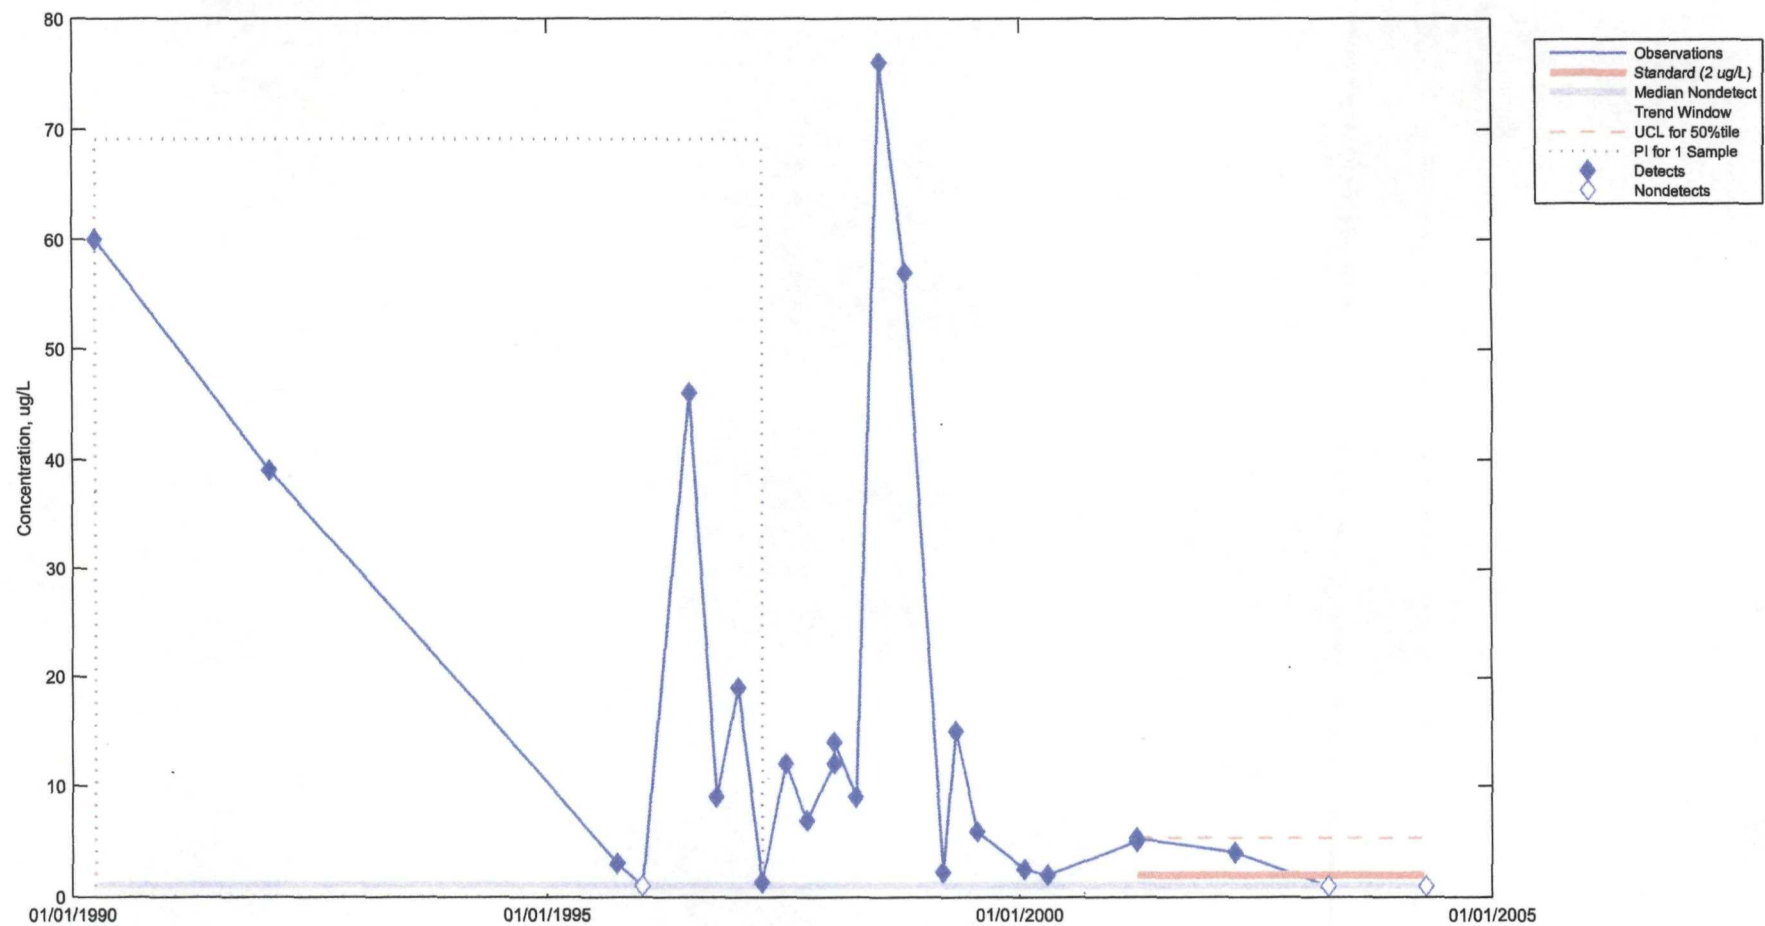
**SW-3
VINYL CHLORIDE
Hi Mill**

Standard Test (95%): Exceedance <UCL = 5.36e+000 ug/L>
 Baseline Test (95%): No Change <UPL/LPL = 6.91e+001/0.00e+000 ug/L>
 Trend Test (95%): Downward <Slope = -1.92e+000 ug/L/year>

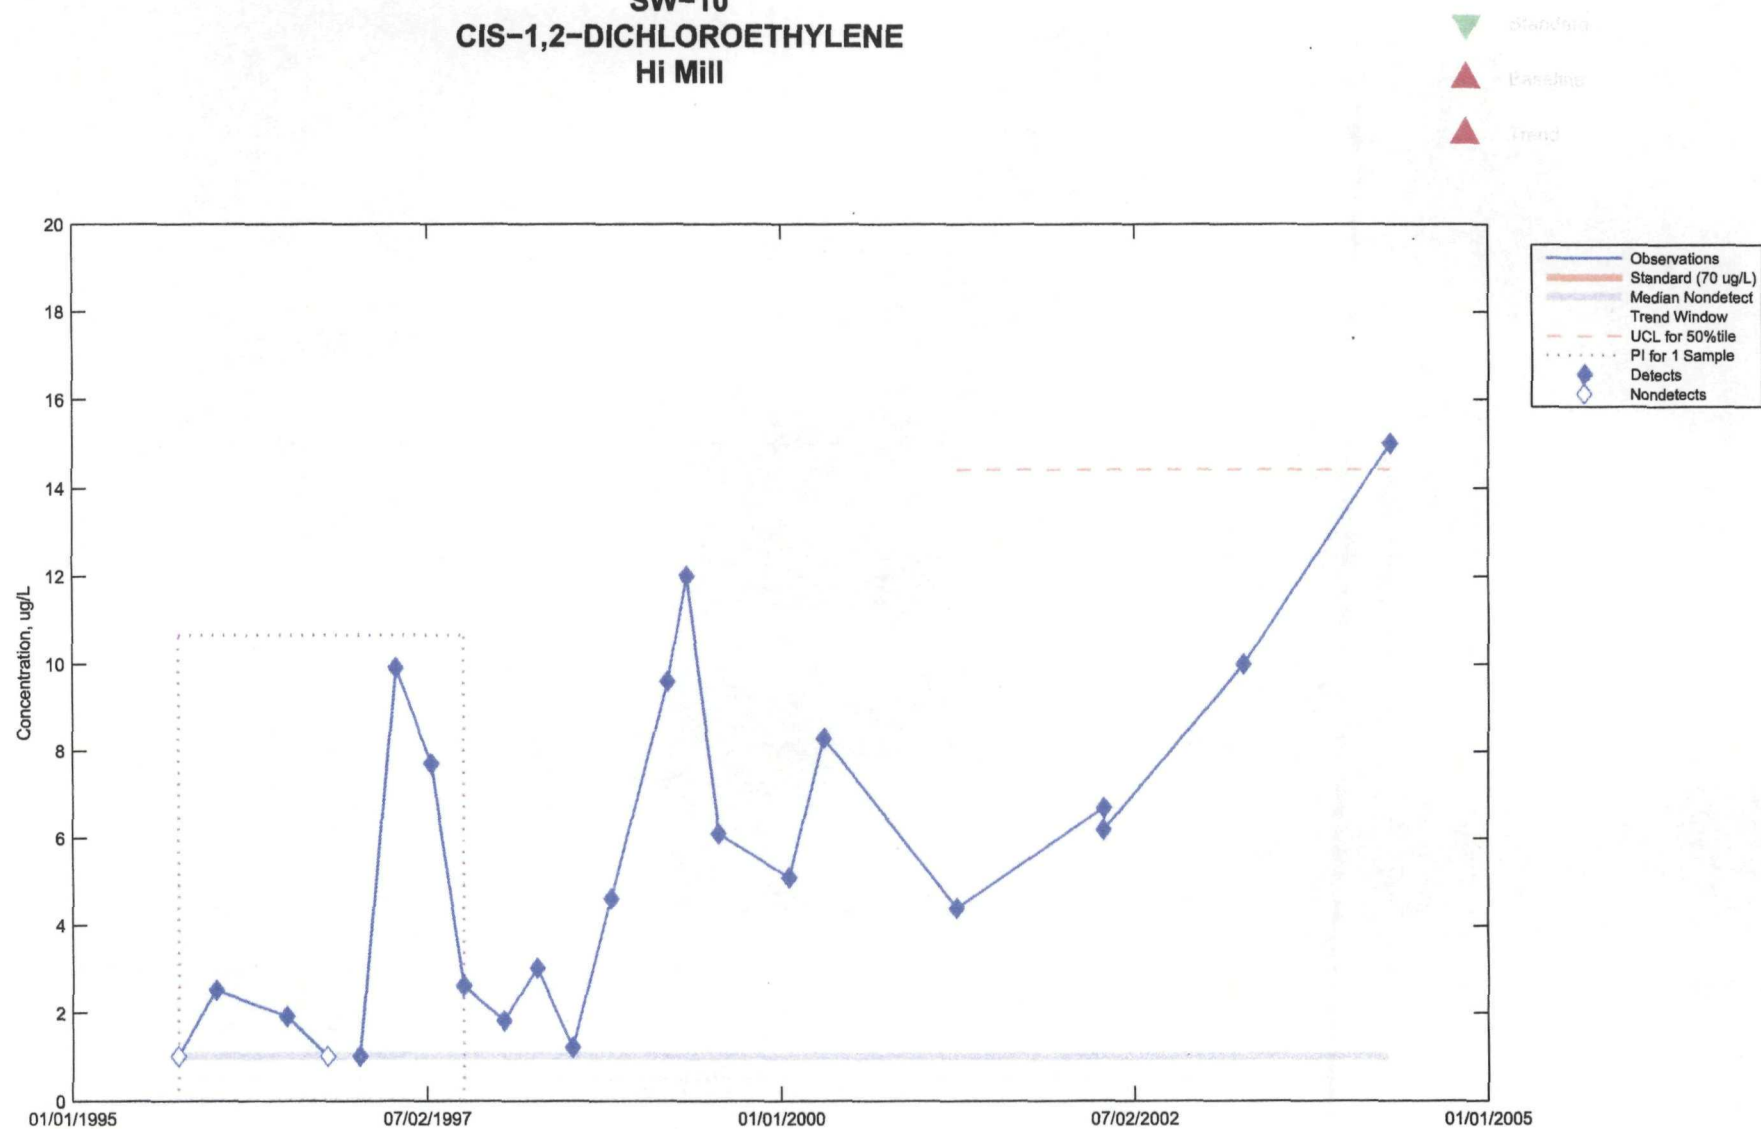
**SW-10
CIS-1,2-DICHLOROETHYLENE
Hi Mill**

Standard Test (95%): Compliance <UCL = 1.44e+001 ug/L>
 Baseline Test (95%): Worse <UPL/LPL = 1.07e+001/0.00e+000 ug/L>
 Trend Test (95%): Upward <Slope = 1.16e+000 ug/L/year>

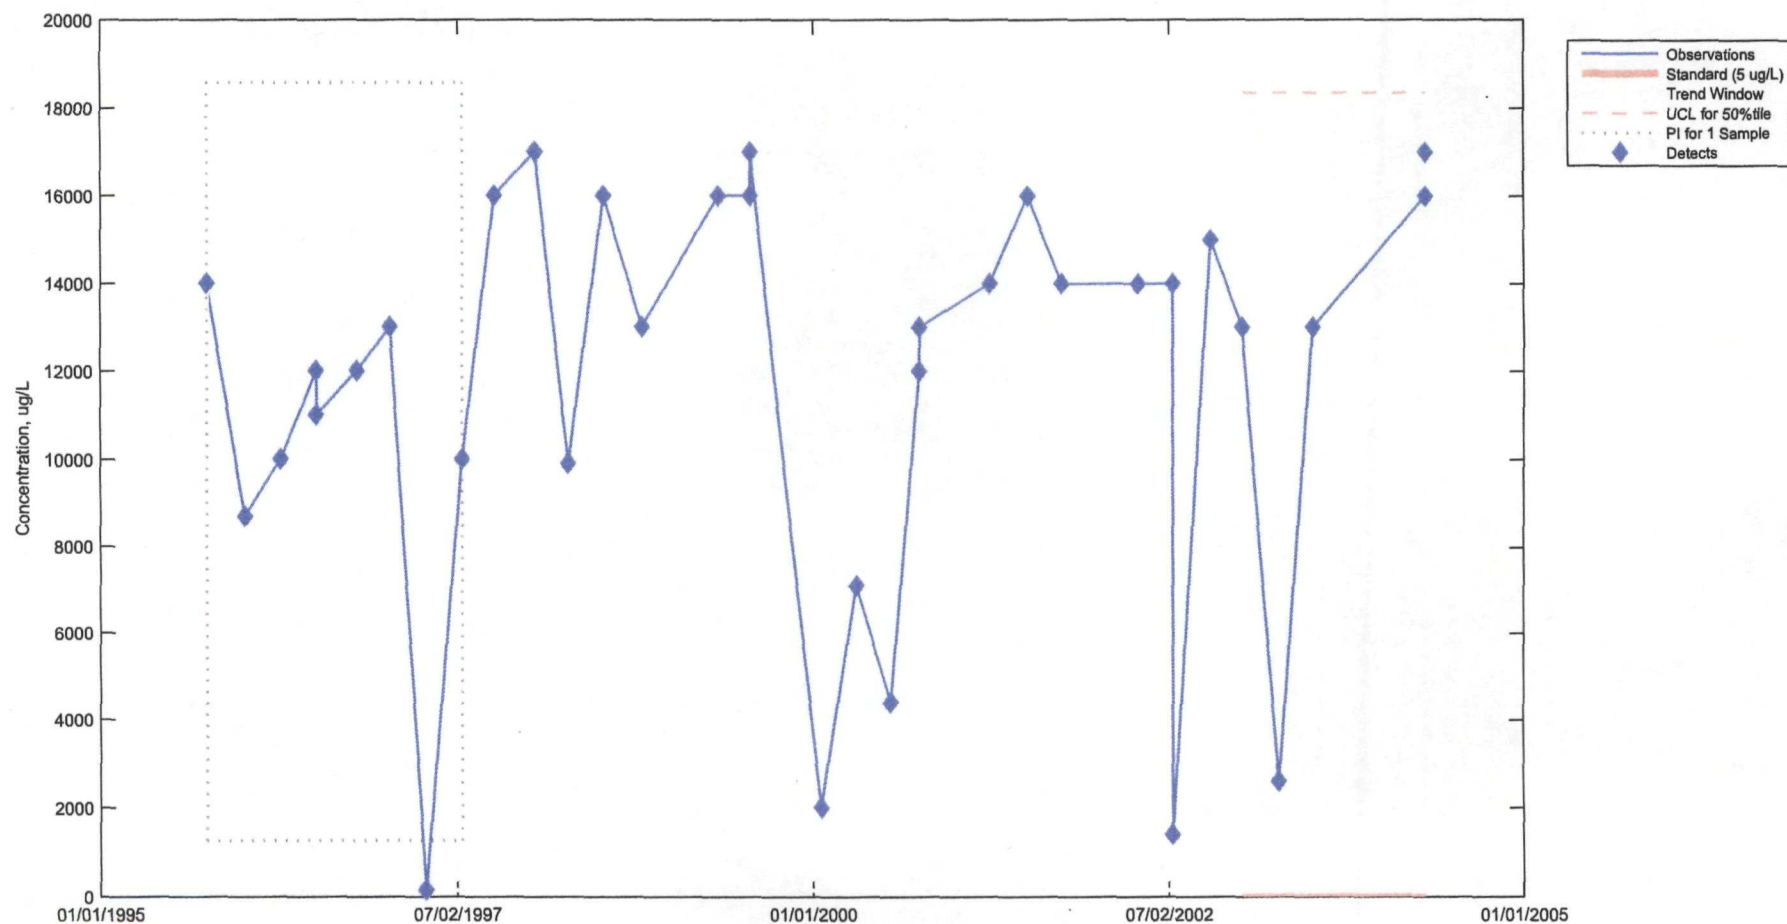
**SW-24
TRICHLOROETHYLENE (TCE)
Hi Mill**

Standard Test (95%): Exceedance <UCL = 1.84e+004 ug/L>
 Baseline Test (95%): No Change <UPL/LPL = 1.86e+004/1.25e+003 ug/L>
 Trend Test (95%): No Trend <Slope = 2.01e+002 ug/L/year>

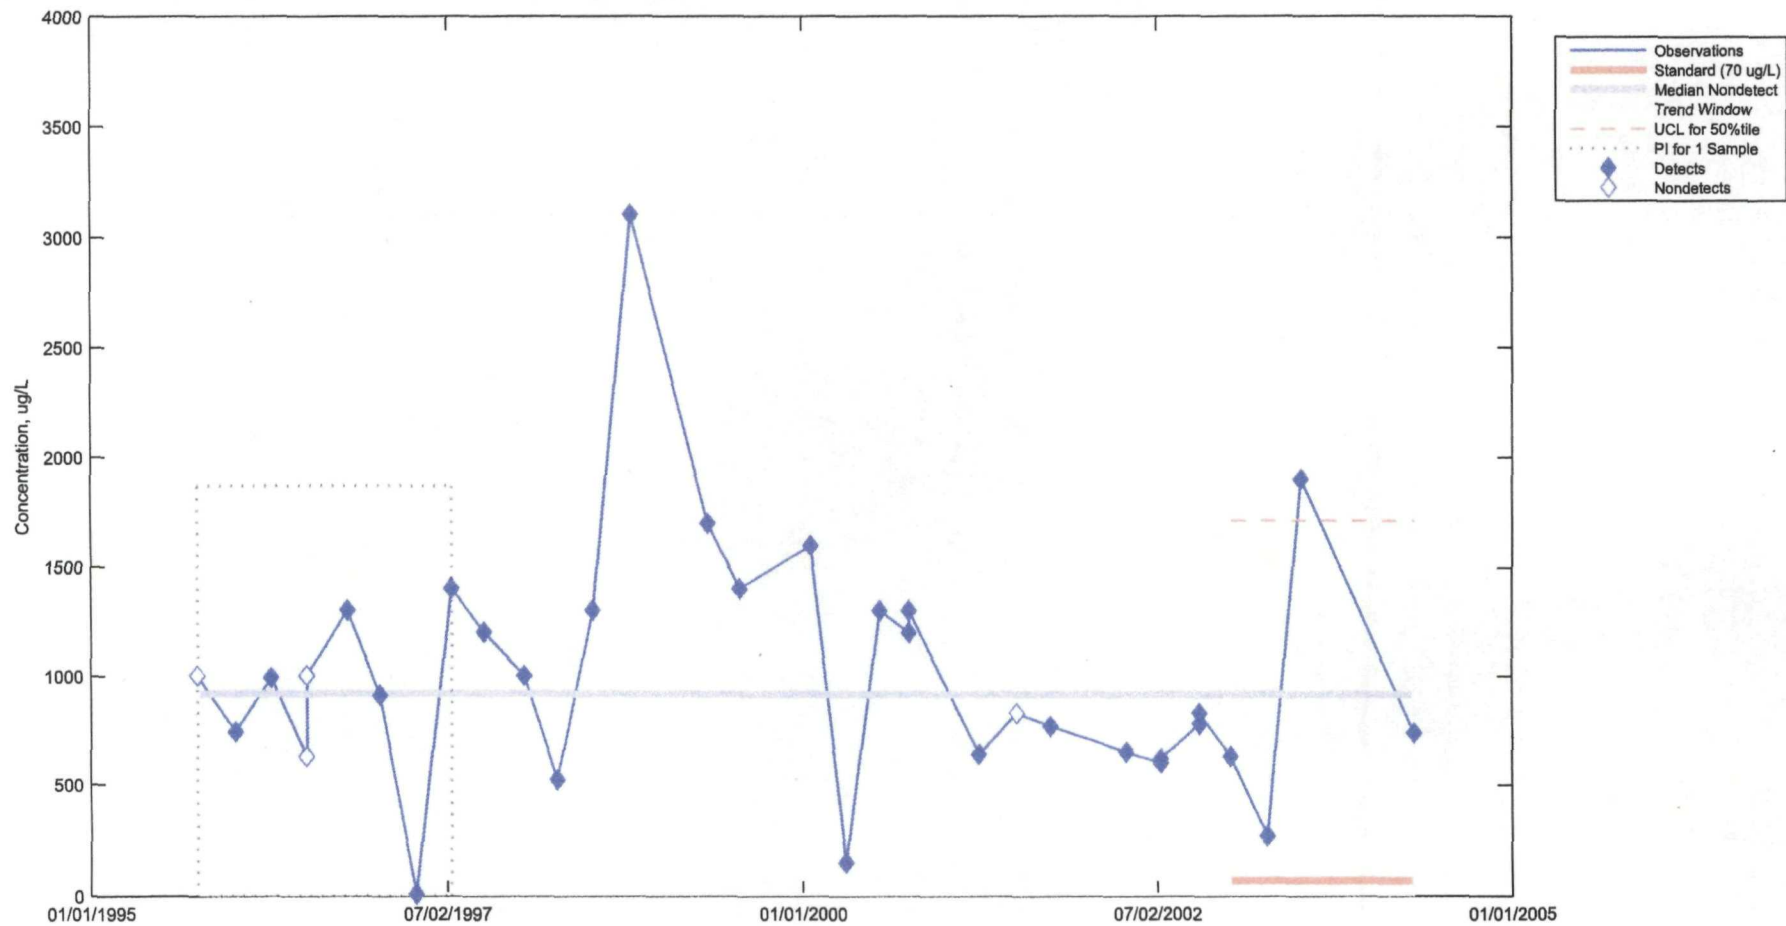
**SW-24
CIS-1,2-DICHLOROETHYLENE
Hi Mill**

Standard Test (95%): Exceedance <UCL = 1.72e+003 ug/L>
 Baseline Test (95%): No Change <UPL/LPL = 1.87e+003/0.00e+000 ug/L>
 Trend Test (95%): No Trend <Slope = -2.82e+000 ug/L/year>
